CITY OF BOSTON
BOSTON, MASSACHUSETTS

REPORT
OF
INVESTIGATION OF COLLAPSE
AT
HOTEL VENDOME

AUGUST, 1972

SUBJECT: Investigation of Collapse
at Hotel Vendome

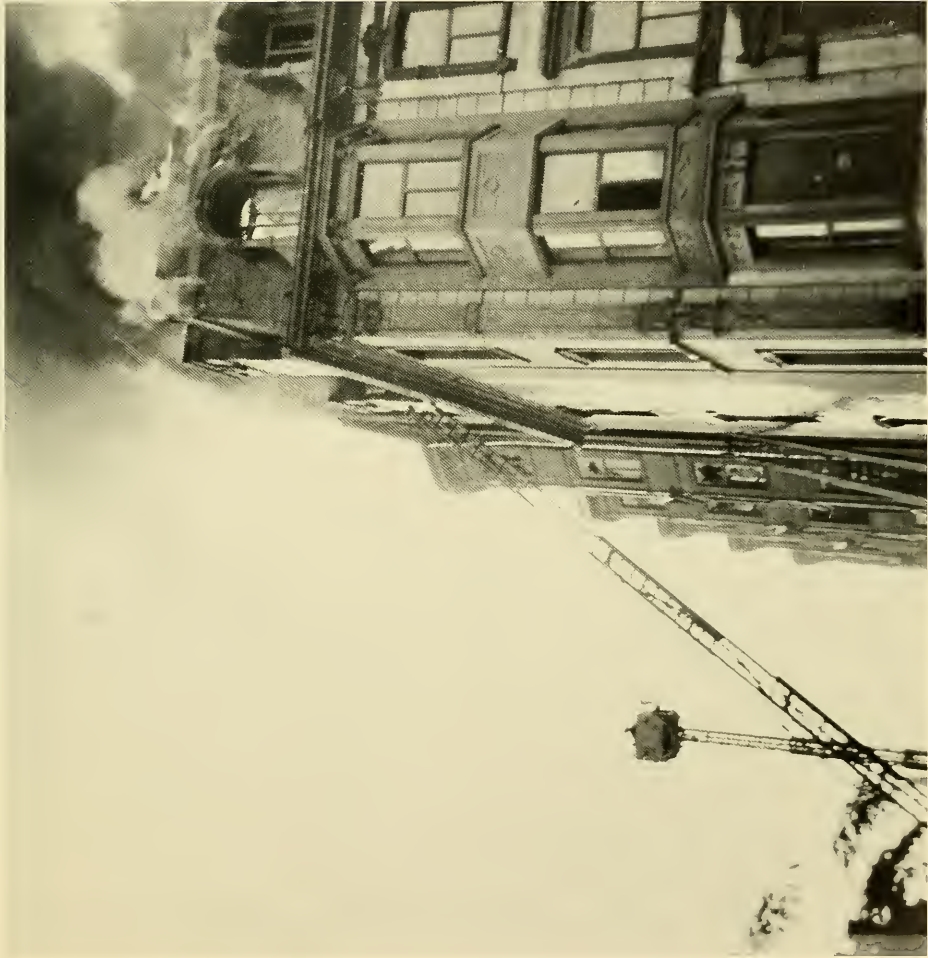
NO. 39

SOUTHEAST CORNER BEFORE COLLAPSE-
NOTE INTENSE FIRE IN ROOF STRUCTURE.
PHOTOGRAPH TAKEN BY JAMES B. FORGIE

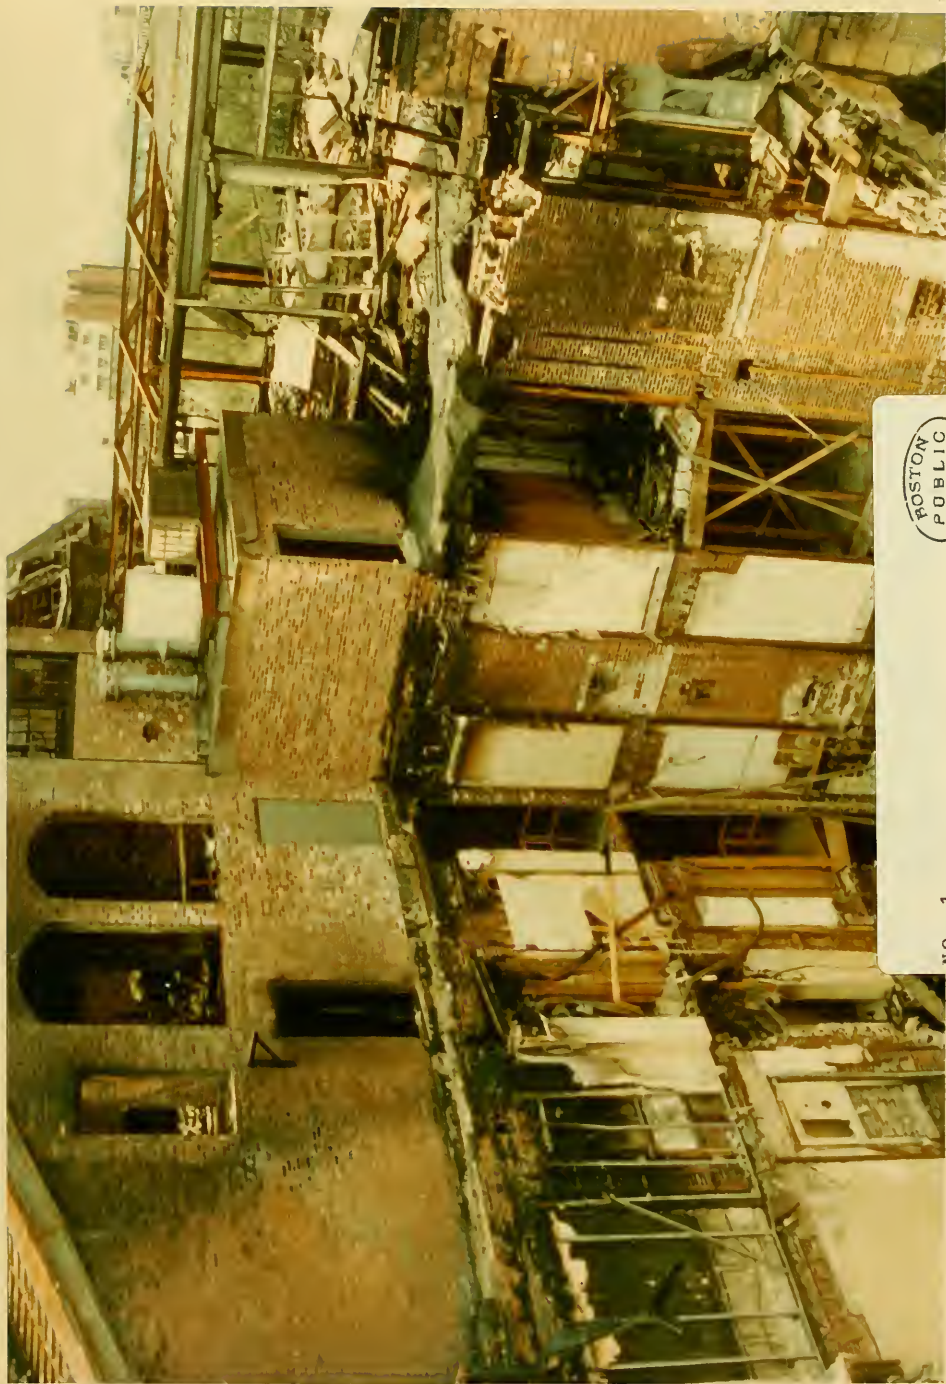
NO. 1
GENERAL VIEW
UPPER SECTION OF COLLAPSE AREA

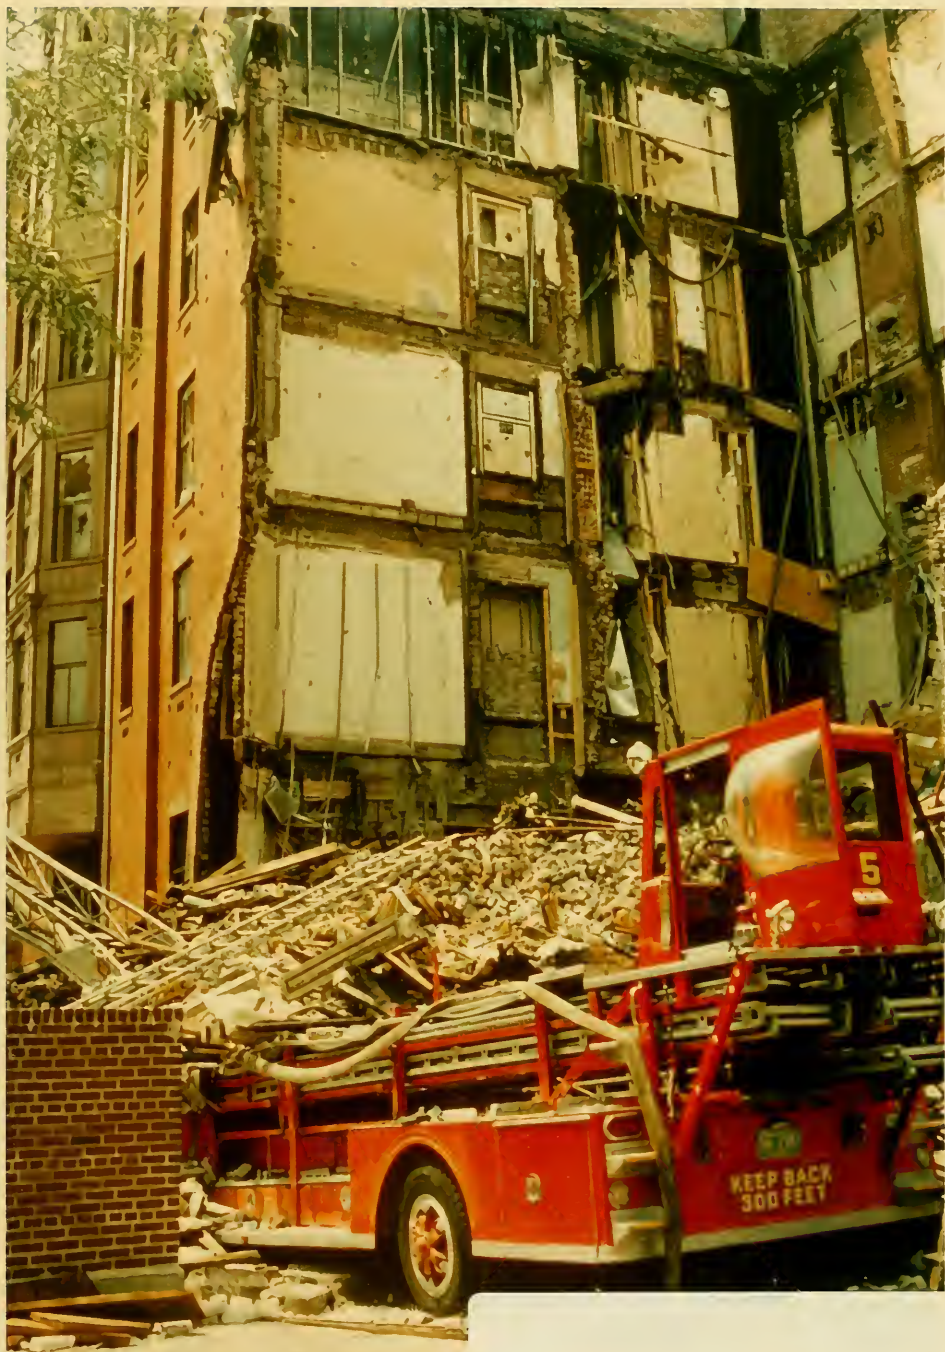
NO. 2
VIEW OF REMAINING WEST WALL

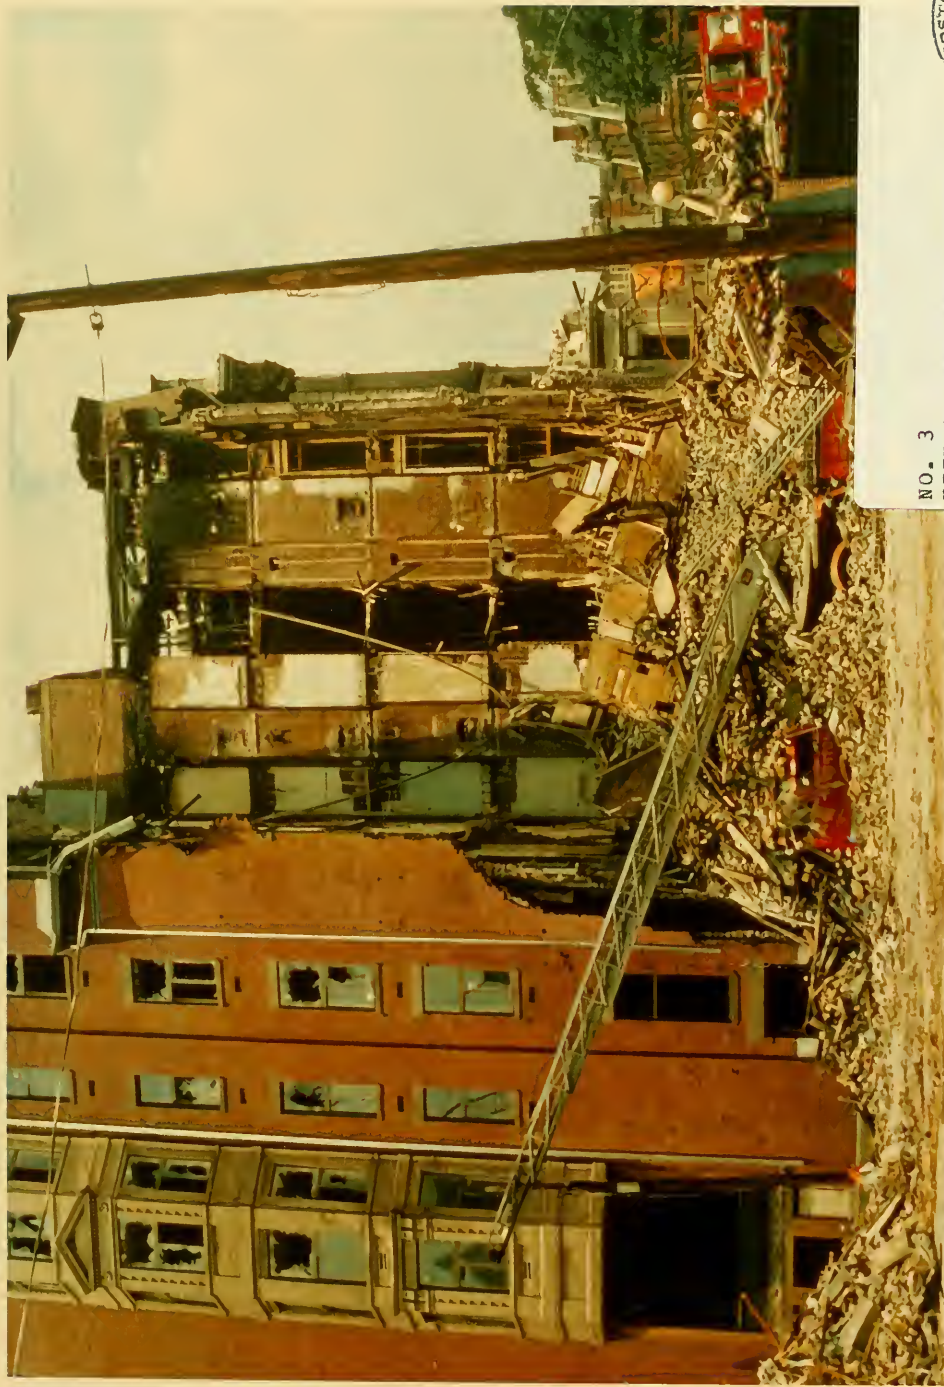
NO. 3

VIEW OF REMAINING NORTH WALL

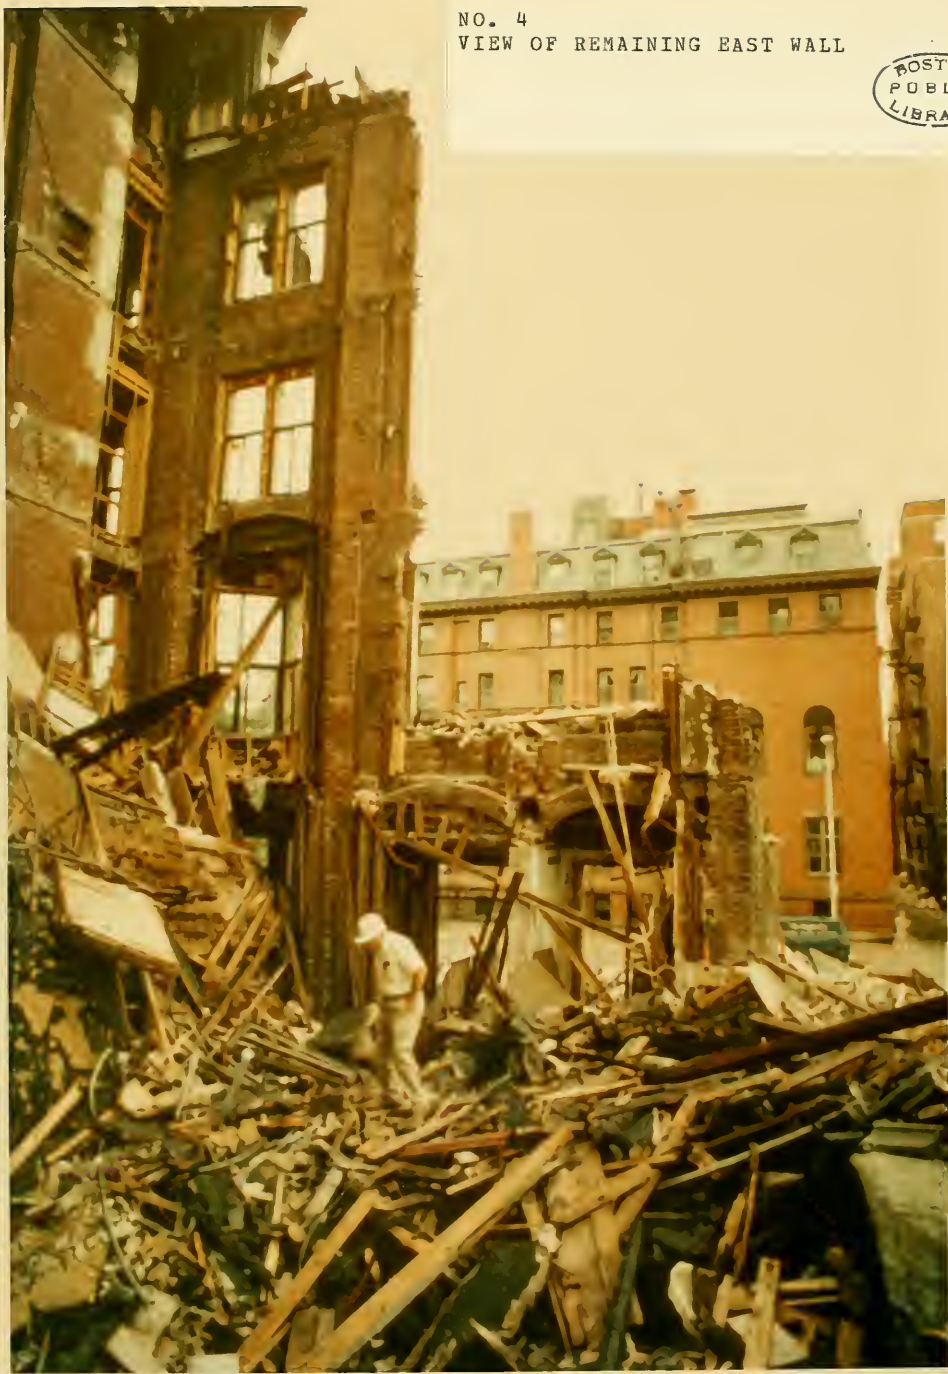
NO. 4

VIEW OF REMAINING EAST WALL

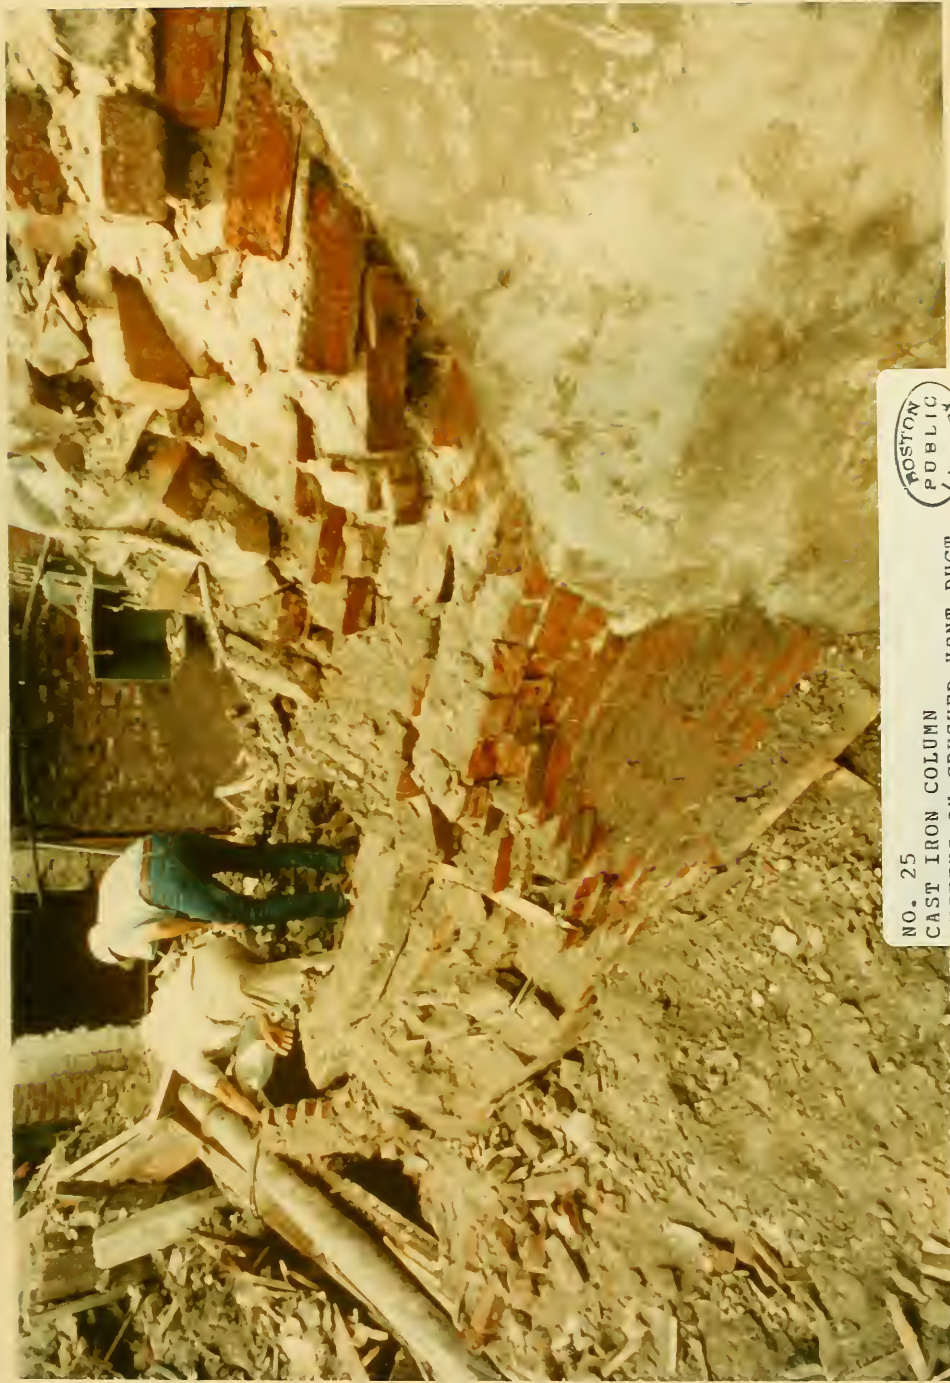
NO. 25

CAST IRON COLUMN
RESTING ON CRUSHED VENT DUCT
IN DOOR OPENING—

NOTE GRANITE BLOCK BEYOND—
NOTE CONDITION OF CENTRAL BEARING WALL.

We believe that the collapse of the structure was caused by a bearing and/or shear failure of the center masonry bearing wall under the cast-iron column at the first floor (upper concourse level), adjacent to the door and duct opening in the wall. (See R6.)

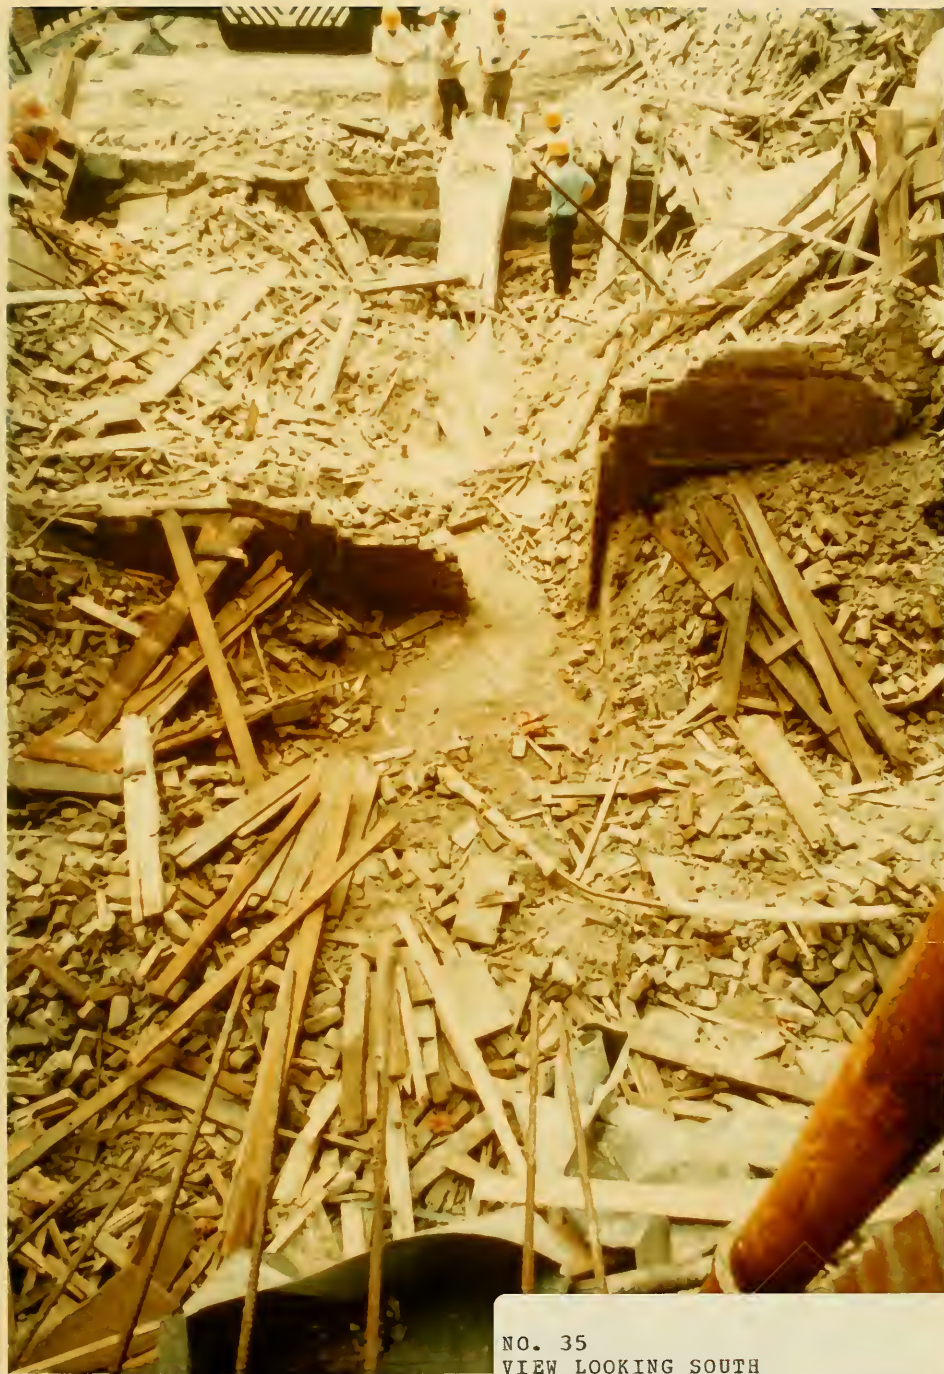
Following removal of all floors and nearly all of the debris a ventilation duct 12" x 30" was exposed in the Basement. All sections of the duct were found and measured. The duct was made of straight sections except for an offset at the south wall to meet a wall louver. Measurement of strap hangers found on the duct and measurements at the north wall showed that the duct had been approximately eight inches below the floor joists.

NO. 35
VIEW LOOKING SOUTH
AT COMPLETION OF SITE INVESTIGATION-
NEAR AND FAR ENDS OF
BASEMENT VENT DUCT SHOWN.

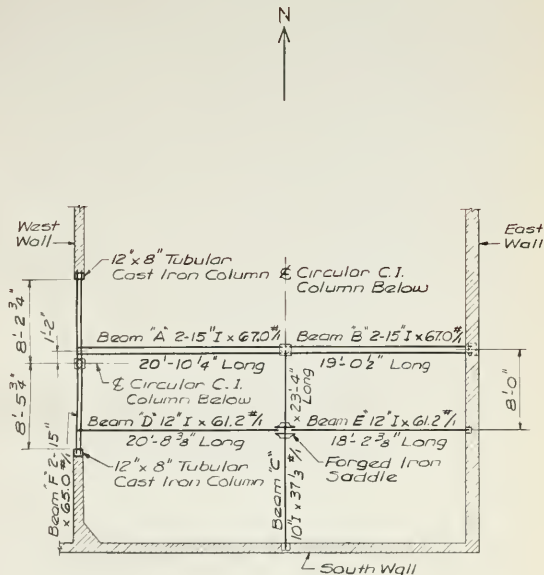
Drawing R3 shows a plan view of this framing as reconstructed with data shown for the various beams.

PLAN
RECONSTRUCTION OF 2ND FLOOR
SUPPORT FRAMING

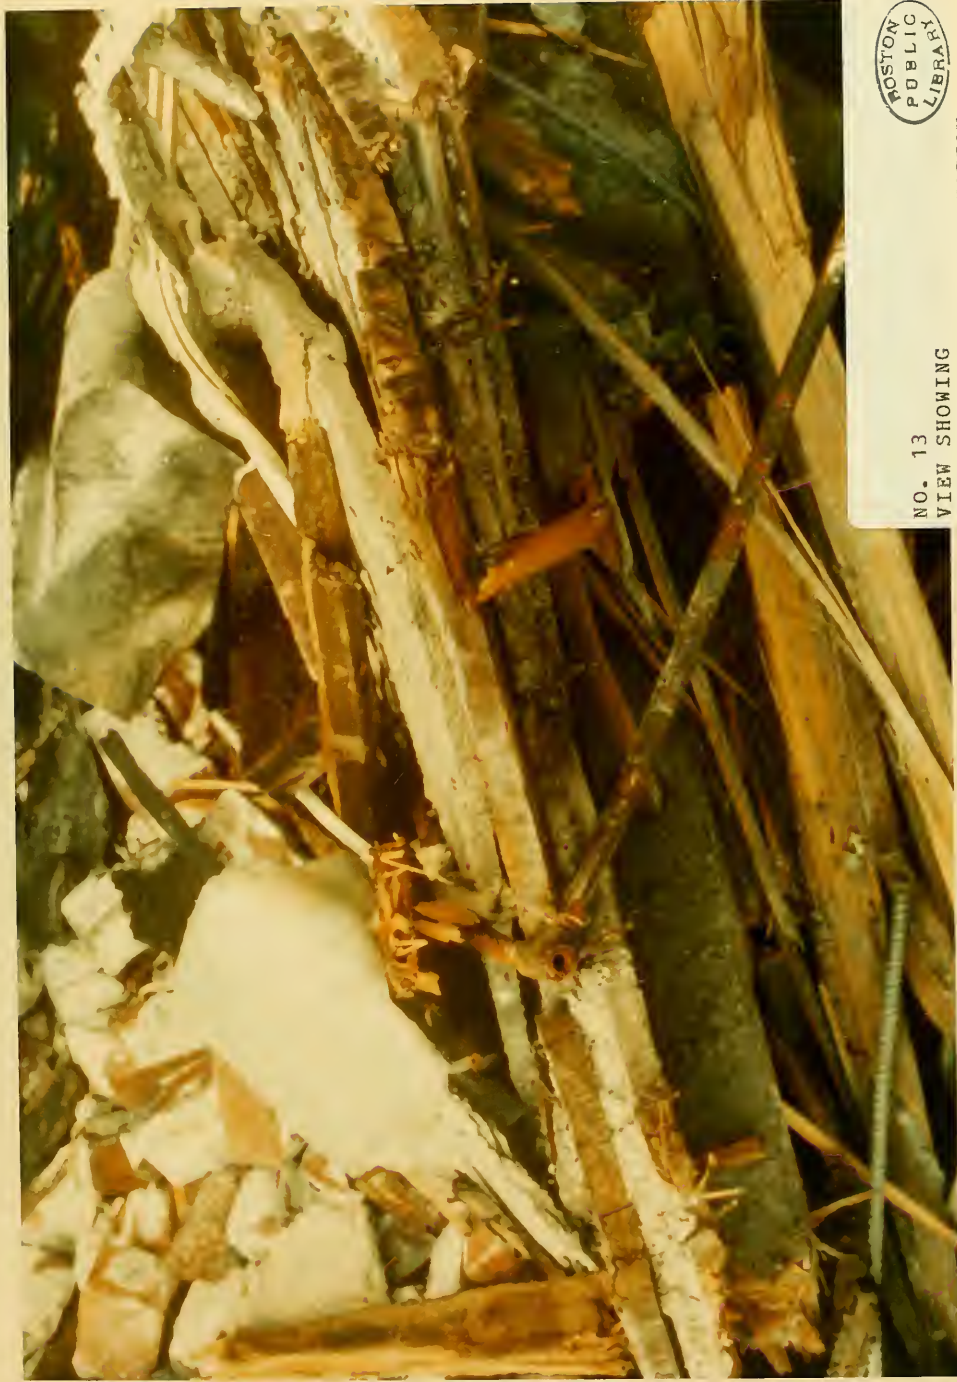
NO. 13

VIEW SHOWING
LAMINATED FLOOR CONSTRUCTION

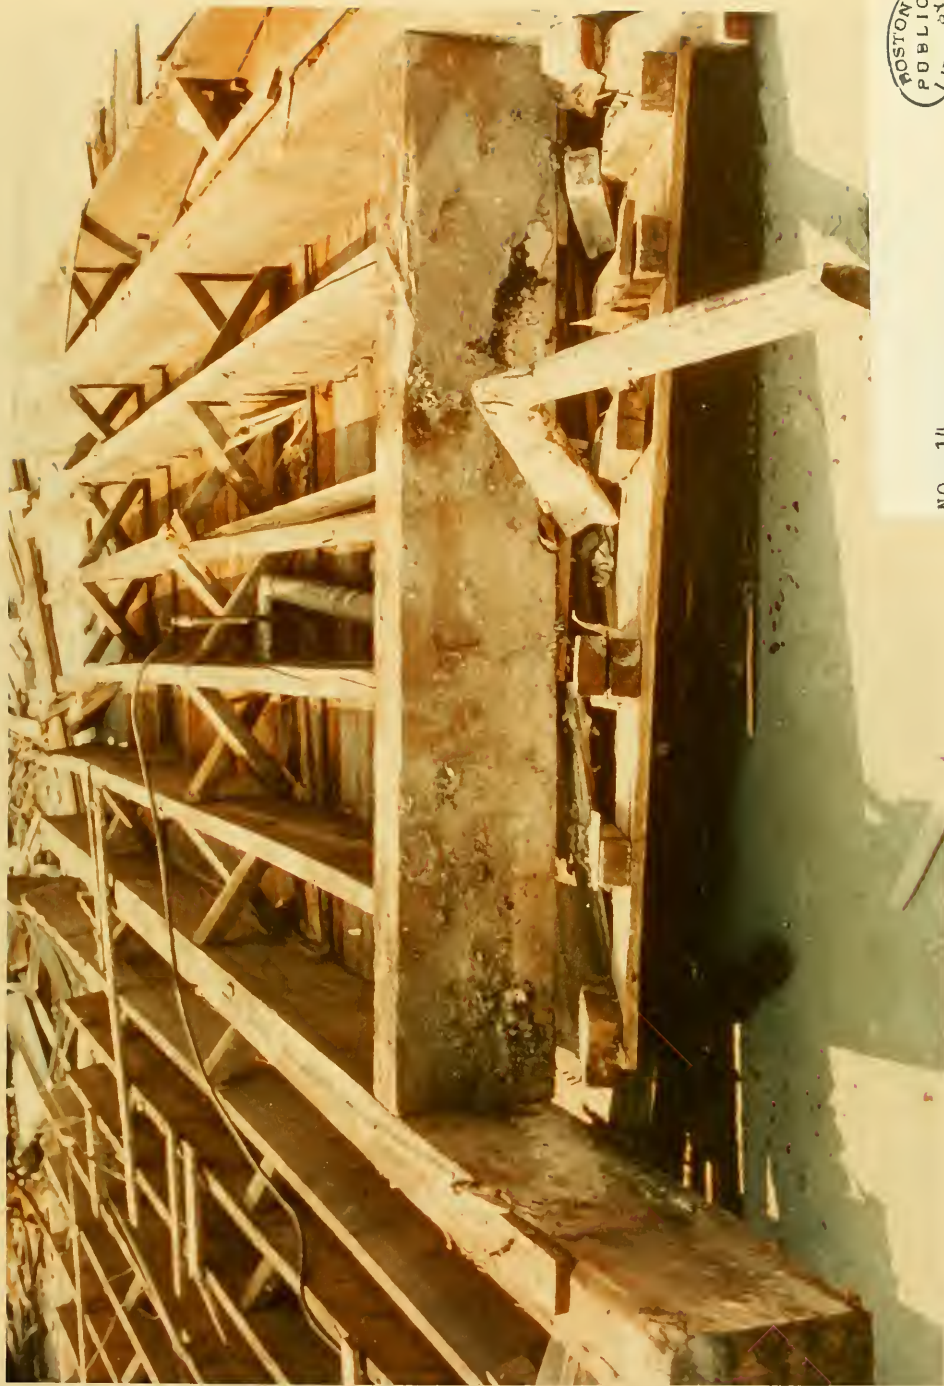
NO. 14
VIEW OF 5TH FLOOR
INVERTED, RESTING IN PARKING LOT.

At 3:00 P.M. a large section of the fifth floor was lifted out and laid down in the parking lot in an inverted position. This section lifted cleanly away from the lath and plaster ceiling, leaving it resting intact against the fourth floor. The floor framing appeared to conform very well with the original plans. The major beams (5" x 12") showed minor checking, but the joists (2" x 12") showed no checking. The floor framing appeared quite sound; most damage occurred from the distortions caused from lifting it as a unit.

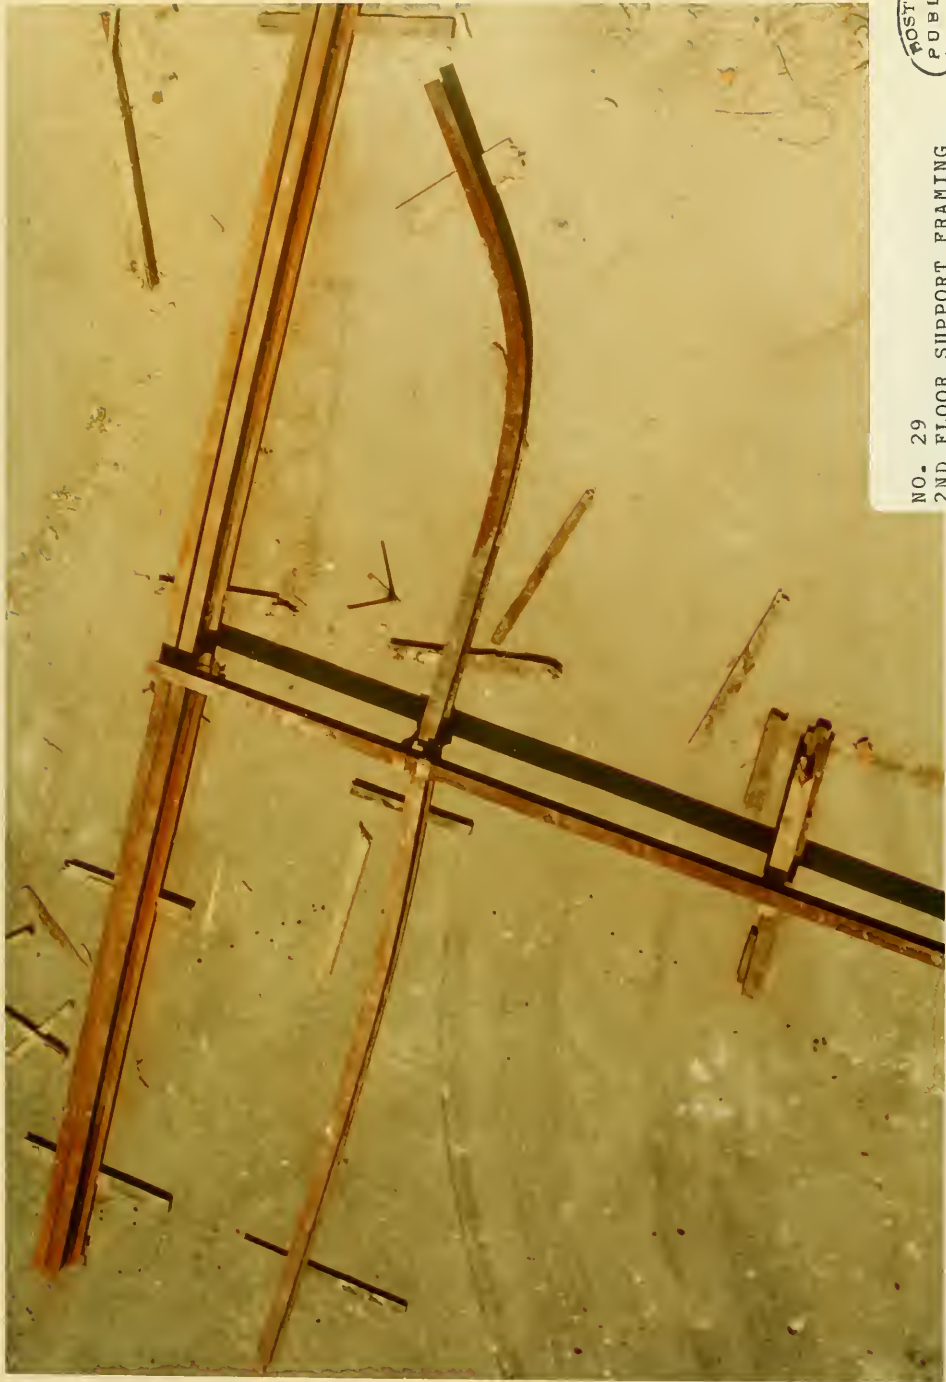
NO. 29

2ND FLOOR SUPPORT FRAMING
RE-ASSEMBLED IN PARKING LOT-
AS PHOTOGRAPHED FROM BUCKET ON CRANE.

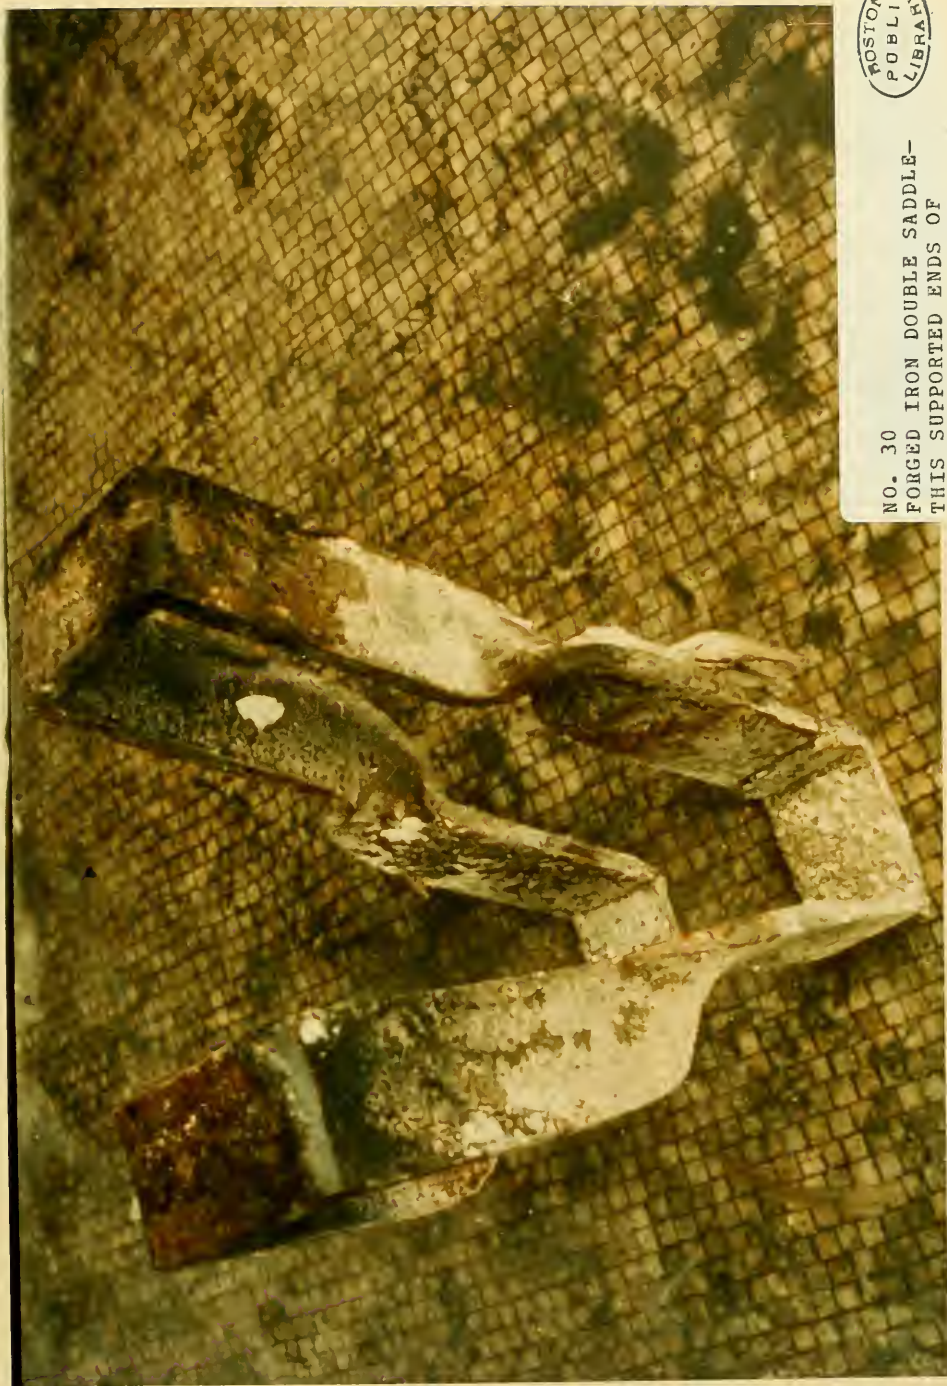
NO. 30
FORGED IRON DOUBLE SADDLE-
THIS SUPPORTED ENDS OF
BEAMS 'D' AND 'E' FROM BEAM 'C'.

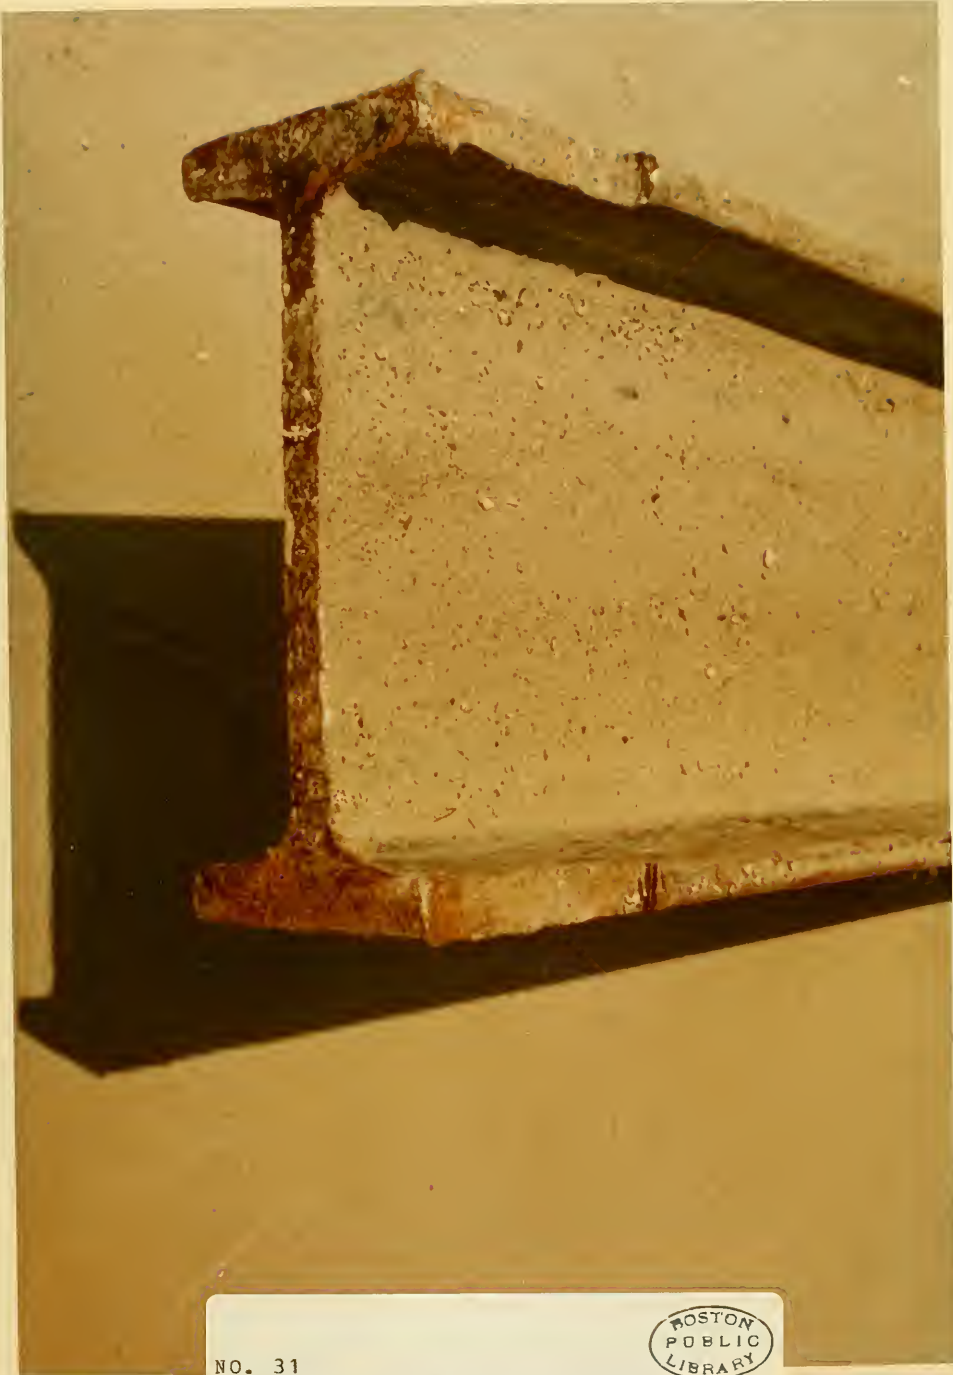
NO. 31

END OF 12 I BEAM ('D' OR 'E')—

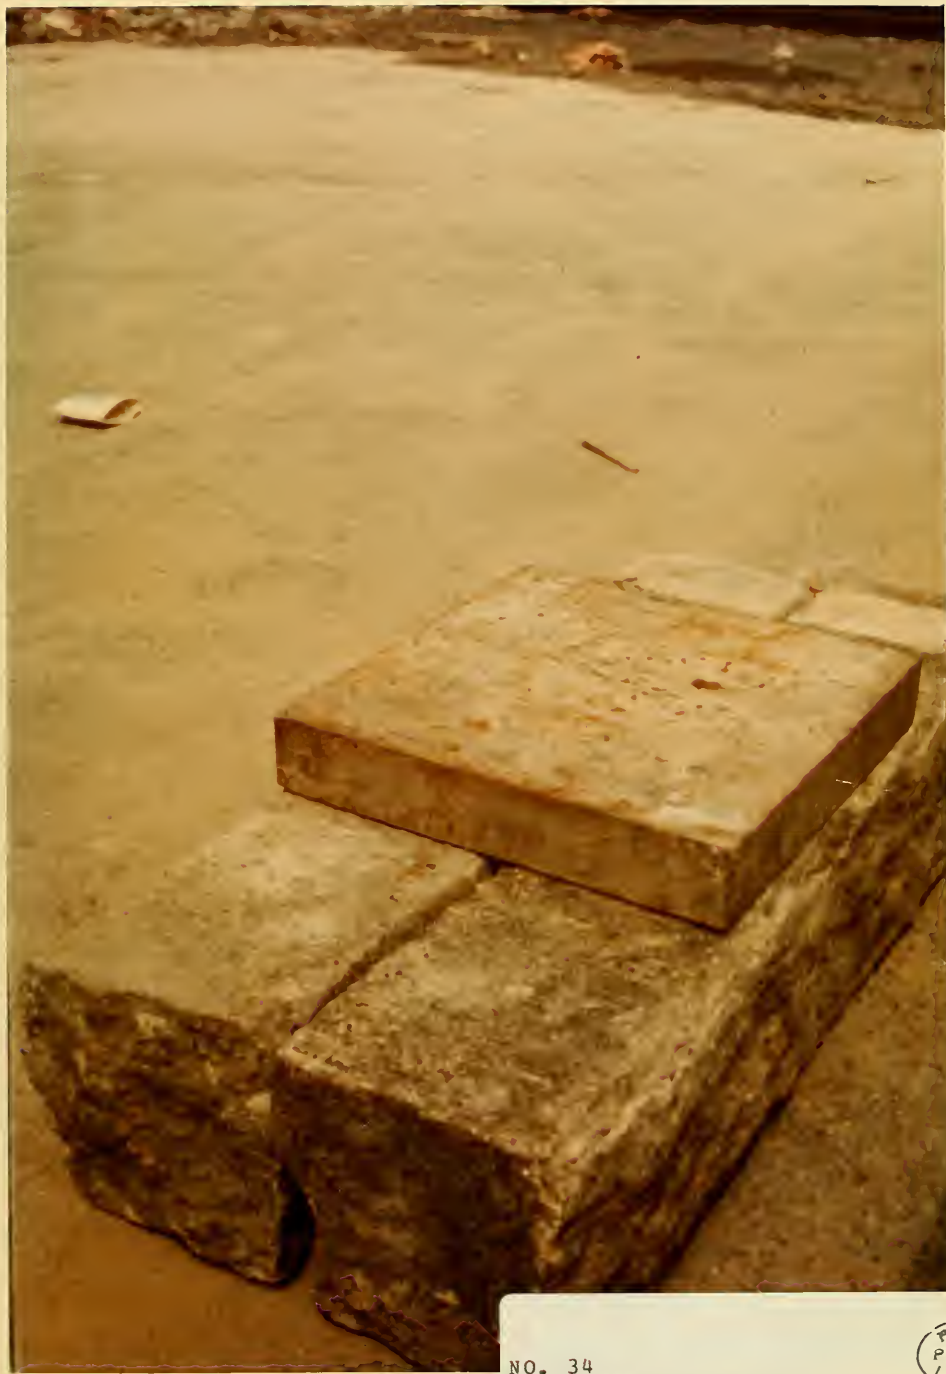
NO. 34
END VIEW OF BASEPLATE AND
BEARING BLOCKS (RE-ASSEMBLED)

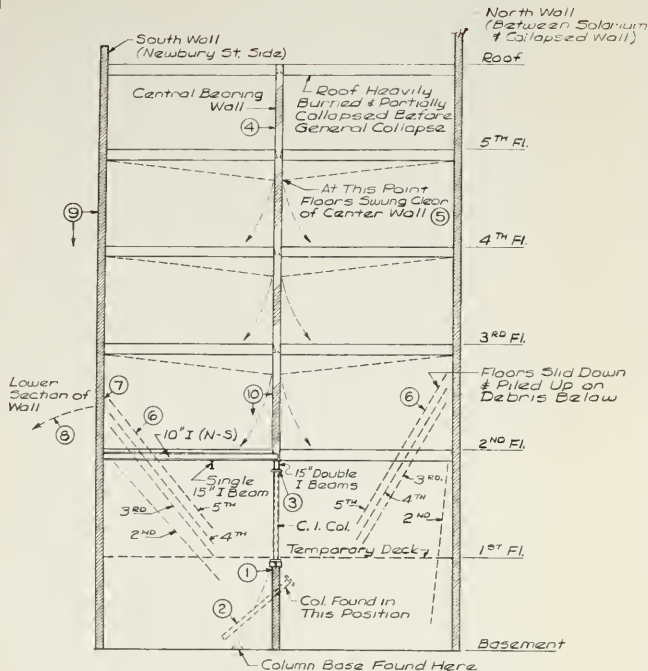
It is our opinion that the collapse was initiated by a bearing and/or shear failure of the bearing wall under a single central column between the second floor and the first floor (upper concourse level). The failure allowed this cast-iron column to drop to the basement level resulting in a complete collapse of the upper floors. (See R5 and R6.)

DIAGRAM OF COLLAPSE

- 1 Bearing Wall Fails Under Central Column
- 2 Column Falls into Basement
- 3 15" Double I Beams Drop in Center and Rotate Out of End Bearings.
- 4 Central Wall Starts Dropping.
- 5 When Central Wall Drops Two Feet, Floor Systems Slip Free.
- 6 Floor Systems Swing Against Walls, Break Free and Slide into Basement.
- 7 Floor Systems Lie Against Newbury Street Wall.
- 8 Lower Portion of Newbury Street Wall Gives Way Under Pressure From Floors. Rotates Outward, Burying Fire Engine.
- 9 Upper Part of Newbury Street Wall Collapses on Top of Debris.
- 10 Meanwhile, Central Wall Has Fallen into Basement Along With Fragments of Roof.

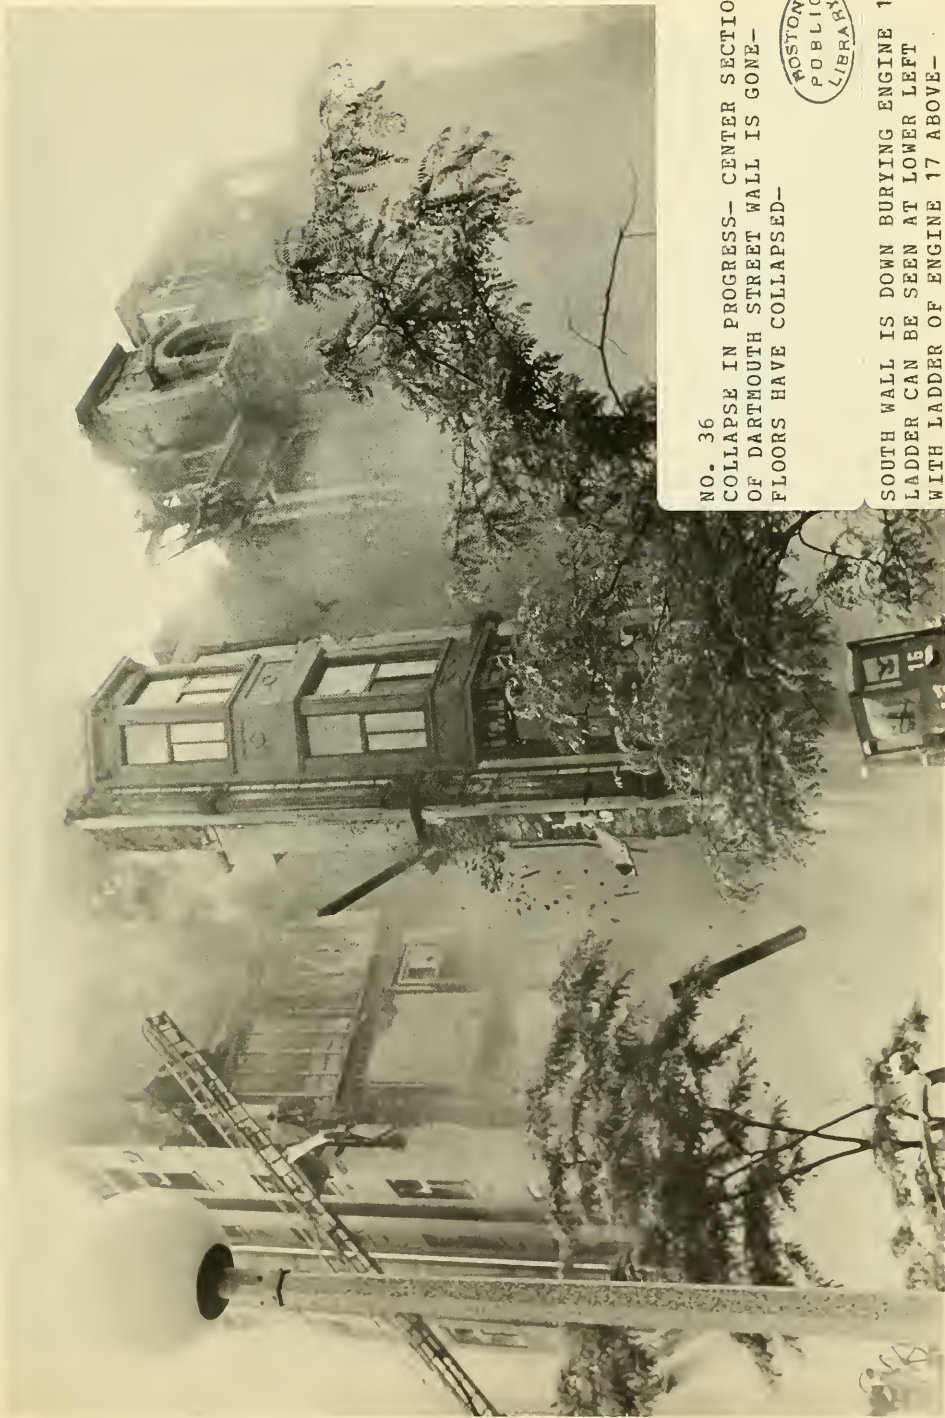
SOUTH WALL IS DOWN BURYING ENGINE 15-
LADDER CAN BE SEEN AT LOWER LEFT
WITH LADDER OF ENGINE 17 ABOVE-
BAY WINDOW SECTION OF
DARTMOUTH STREET WALL
IS STILL STANDING.
PHOTOGRAPH TAKEN BY DONALD DIETZ

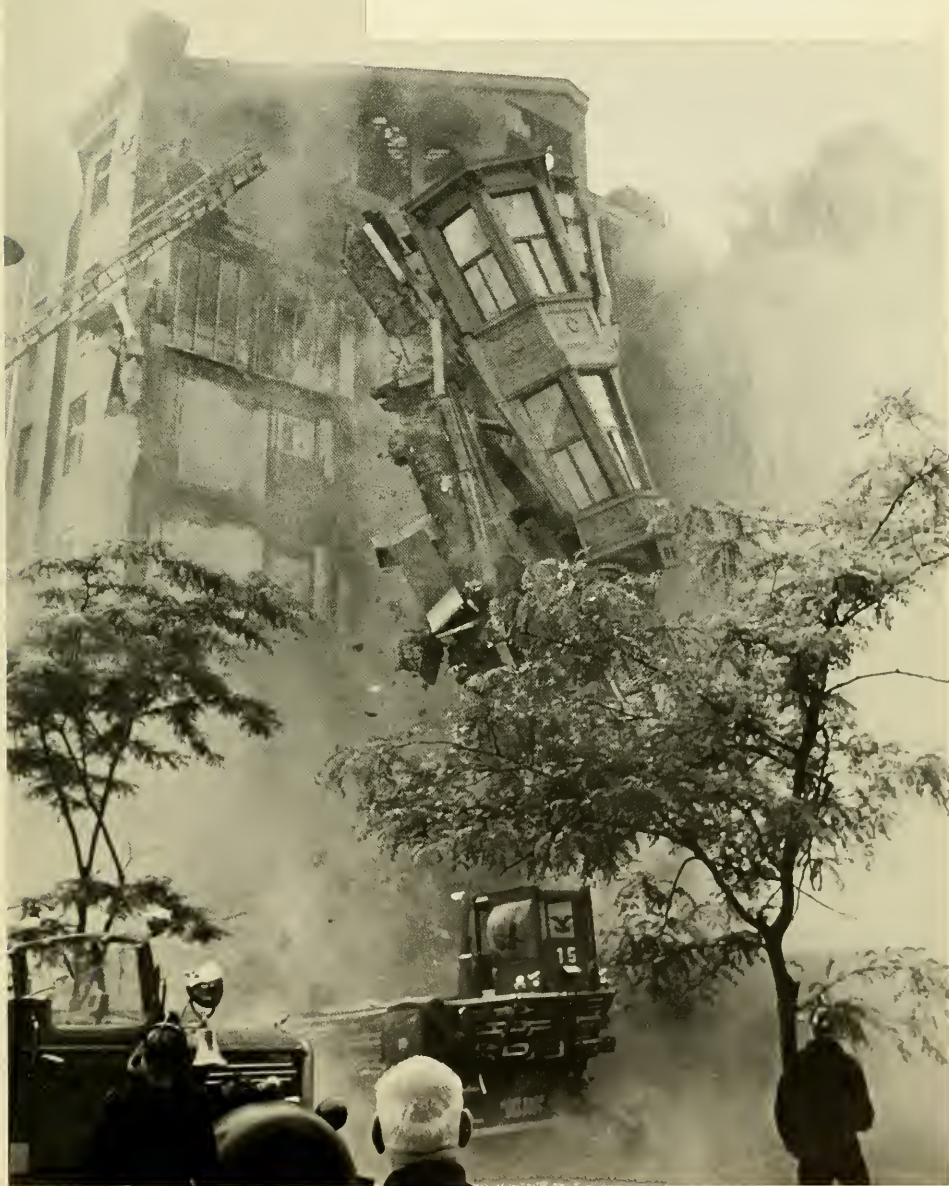
NO. 37

FINAL PHASE OF COLLAPSE

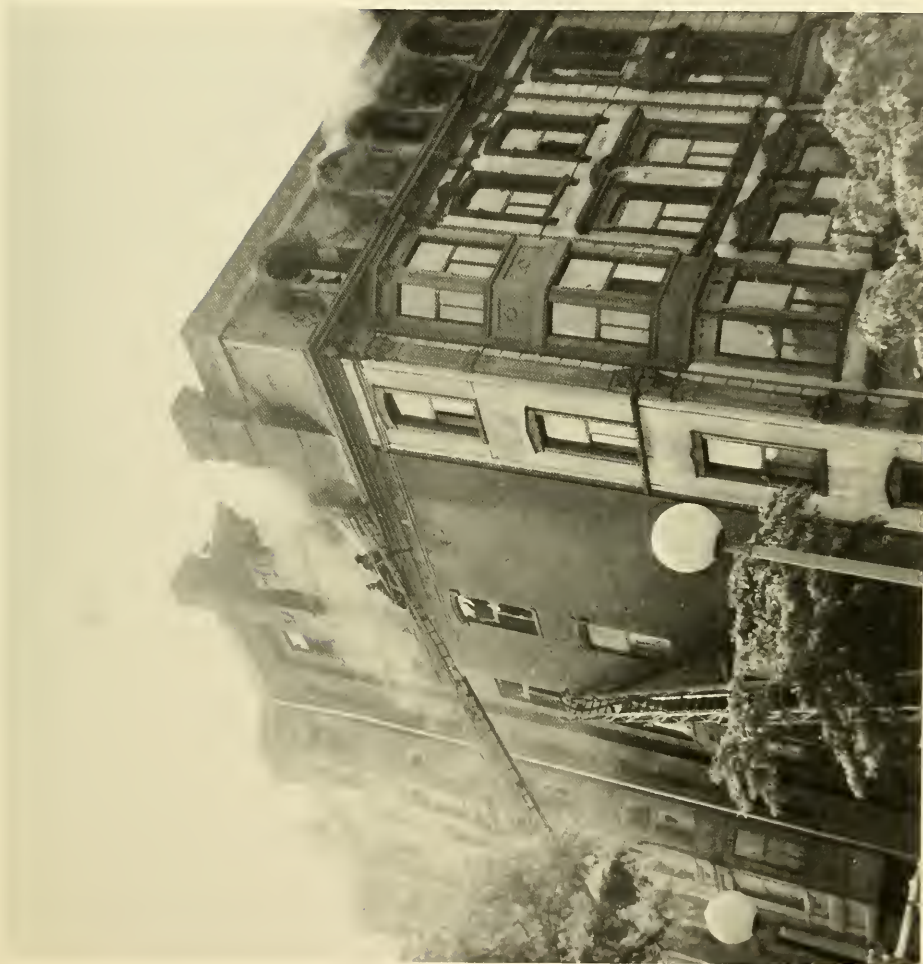
NO. 38
SOUTHEAST CORNER BEFORE COLLAPSE-
NOTE WINDOWS IN SOUTH WALL
BELOW CHIMNEY-
COMPARE THIS PHOTO WITH NO. 36
PHOTOGRAPH TAKEN BY JAMES B. FORGIE

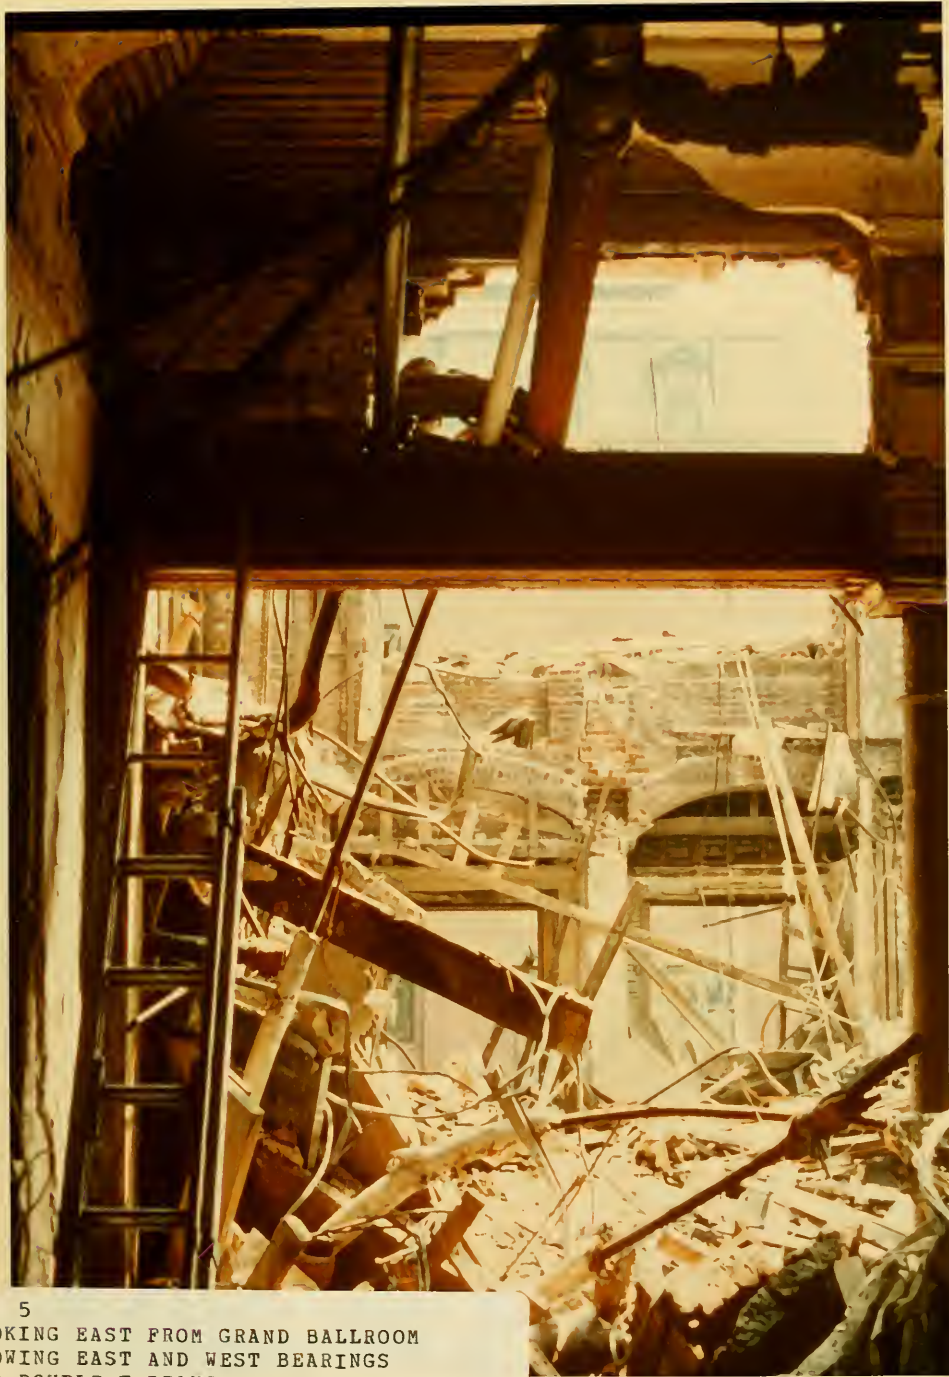
NO. 5
LOOKING EAST FROM GRAND BALLROOM
SHOWING EAST AND WEST BEARINGS
FOR DOUBLE I BEAMS—
END OF DOUBLE I BEAMS 'A'
VISIBLE IN DEBRIS BELOW
